# LIVESTOCK AND VEHICULAR UNDERPASSES IN USE

LIVESTOCK AND VEHICULAR UNDERPASSES IN USE --photographic illustrations

RIGHT-OF-WAY SECTION

STATE OF MONTANA - DEPARTMENT OF HIGHWAYS

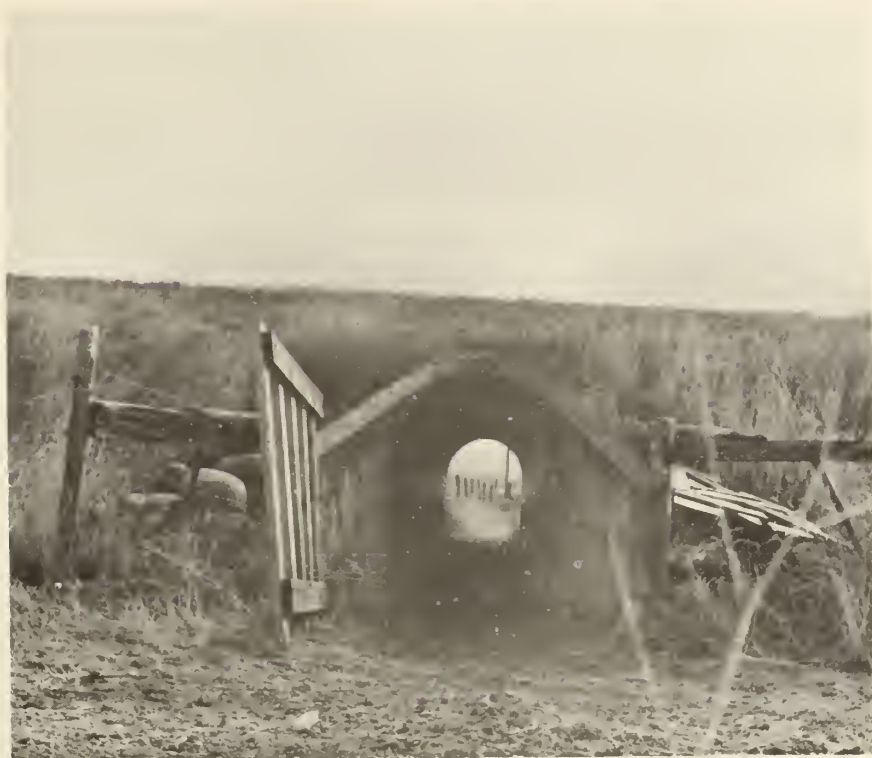
West Entrance

4's x 6'r x 35' long, Concrete Arch S.P., Std. Drg. 63-01. Two miles south of Whitehall. Holstein, Guernsey, Dutch Belton dairy cows, totaling 34 head. Herd was moved to east of highway and back again.

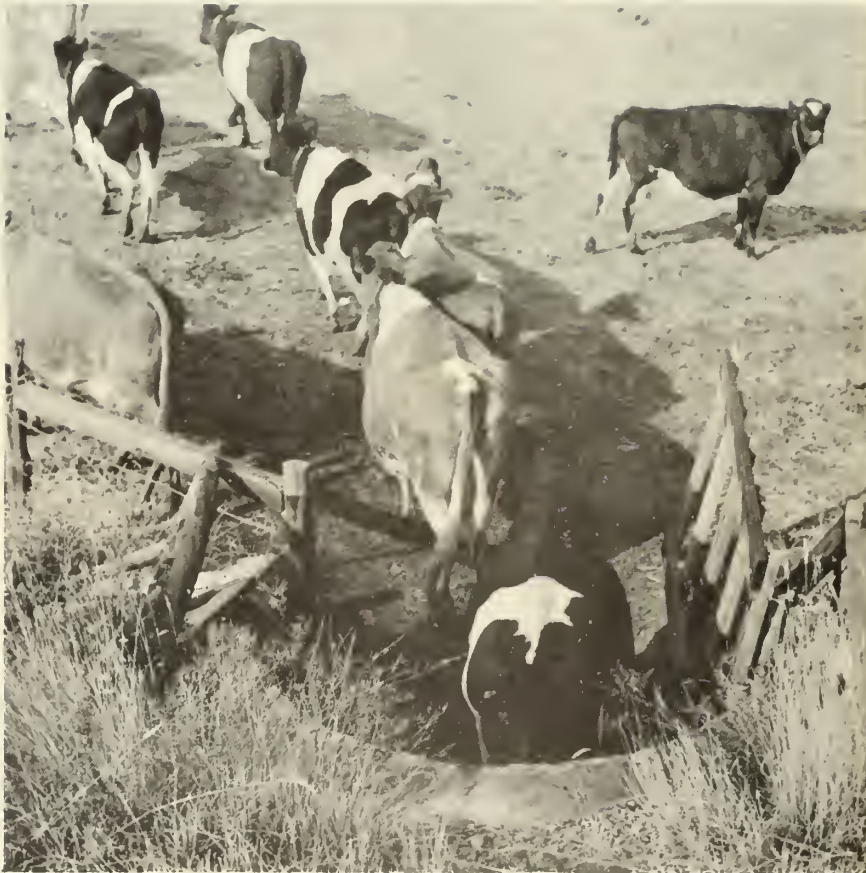
West Exit

4's x 6'r x 35' long, Concrete Arch S.P., Std. Drg. 63-01. Two miles south of Whitehall. Holstein, Guernsey, Dutch Belton dairy cows, totaling 34 head. Cattle did not hesitate except when cameraman stood in front over entrance.

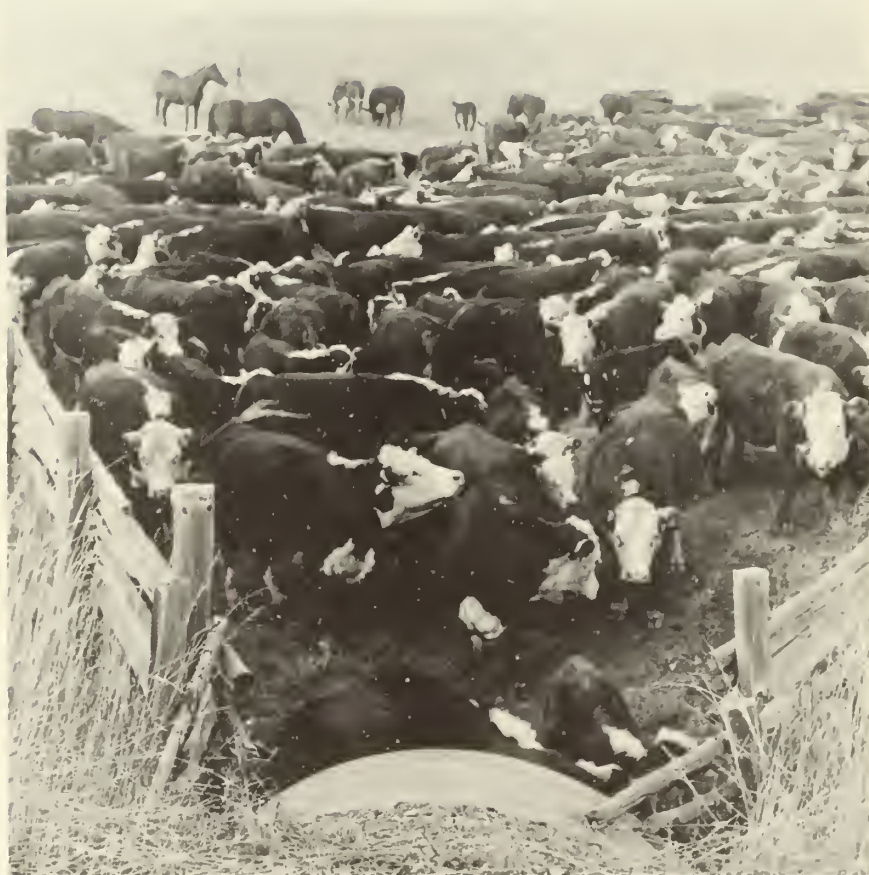
North Holding Corral

5'10''s x 6'6''r x 76' long, Arch C.M.P., Type "A", Std. Drg. 59-02. Herd movement of 250 head into corral and through stockpass. Most of herd was in corral at time of this picture. Notice pole wing fencing. These cattle were reasonably familiar with this structure.

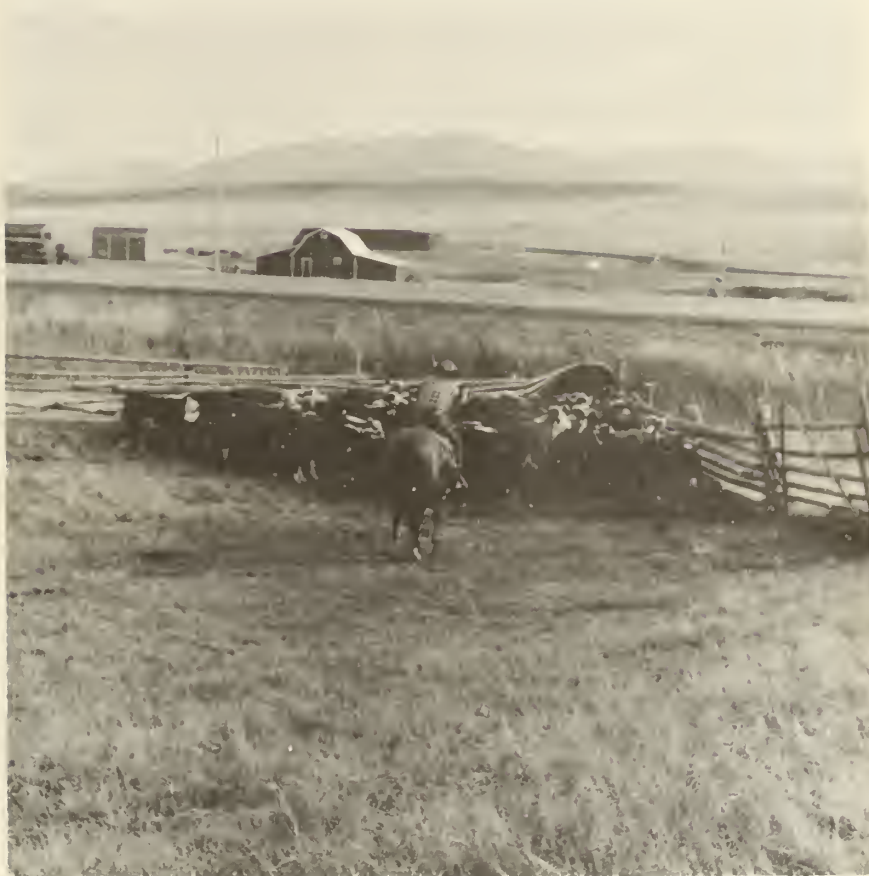
North Holding Corral

5'10''s x 6'6''r x 76' long, Arch C.M.P., Type "A", Std. Drg. 59-02. Herd movement of 250 head into corral and through stockpass. Notice wing fencing which seems to work quite well as a funneling technique. About 4 miles east of Raynesford on 2-lane U.S. #87. Once cattle were started through, there did not seem to be much balking or stopping. This underpass had good utility.

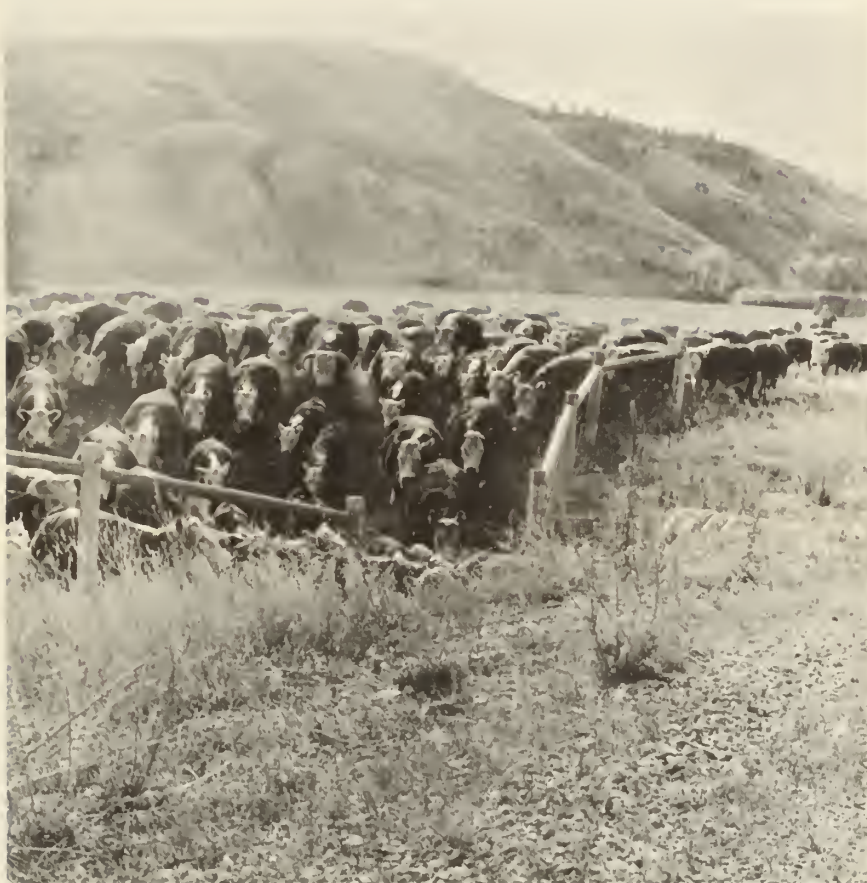
East Entrance

5'10"s x 7'7"r x 88' long, Arch C.M.P., Type "B", Std. Drg. 59-02. No holding pens, gradual wing fencing into recessed (bottom) location. Cattle sluff dirt into bottom, filling east entrance in about 1' in two seasons' use. See Page 14 for cleaning procedure. This stockpass, in spite of this and early season drainage, has very high utility. Just south of the Armington Junction, 3-3/4 miles southeast of Belt on U.S. #89.

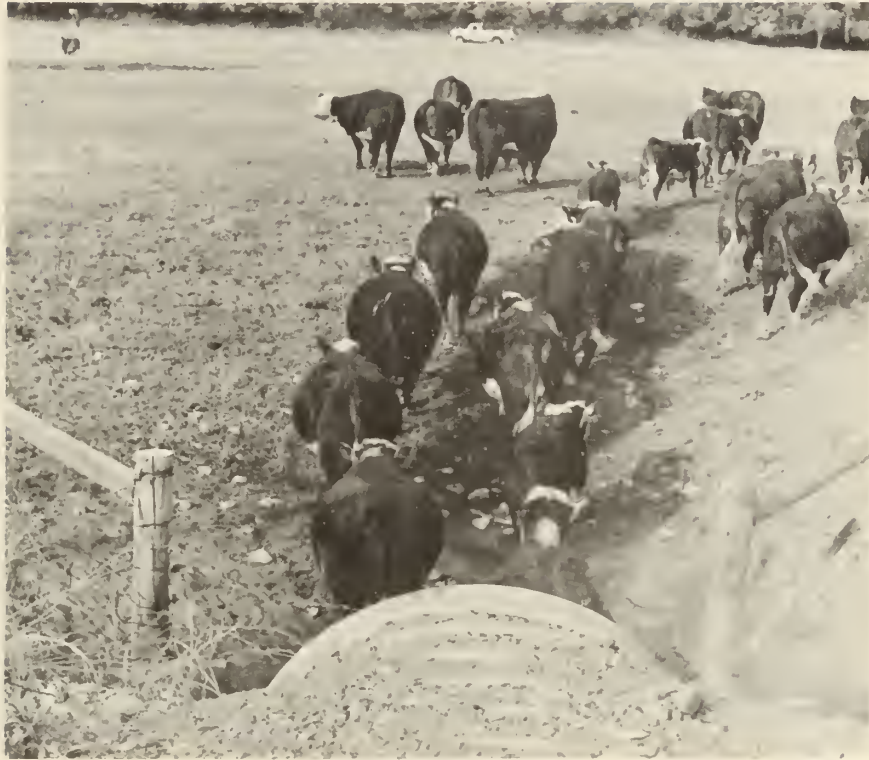
West Exit, Looking From Shoulder

5'10" x 7'7" x 88' long, Arch C.M.P., Type "B", Std. Drg. 59-02. Steady herd movement across meadow to upper pastures. Notice wire tied to stockpass. These cattle were quite familiar with this stockpass; second season in use.

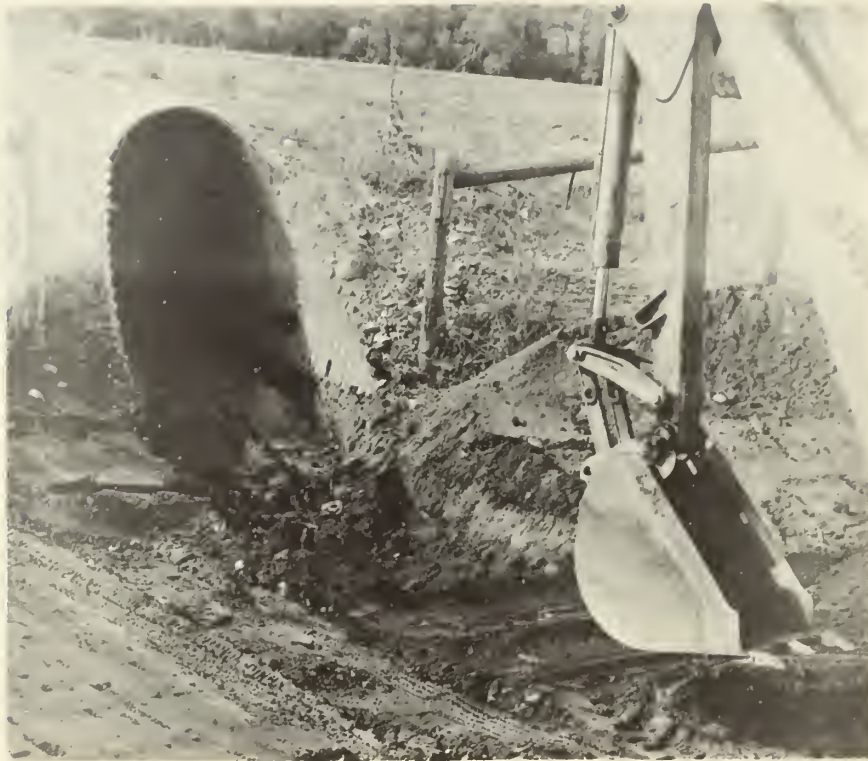
East Entrance

5'10"s x 7'7"r x 88' long, Arch C.M.P., Type "B", Std. Drg. 59-02. Highway employees are using a backhoe front-end loader to remove dirt filled in by herd movement into stockpass, at request of landowner.

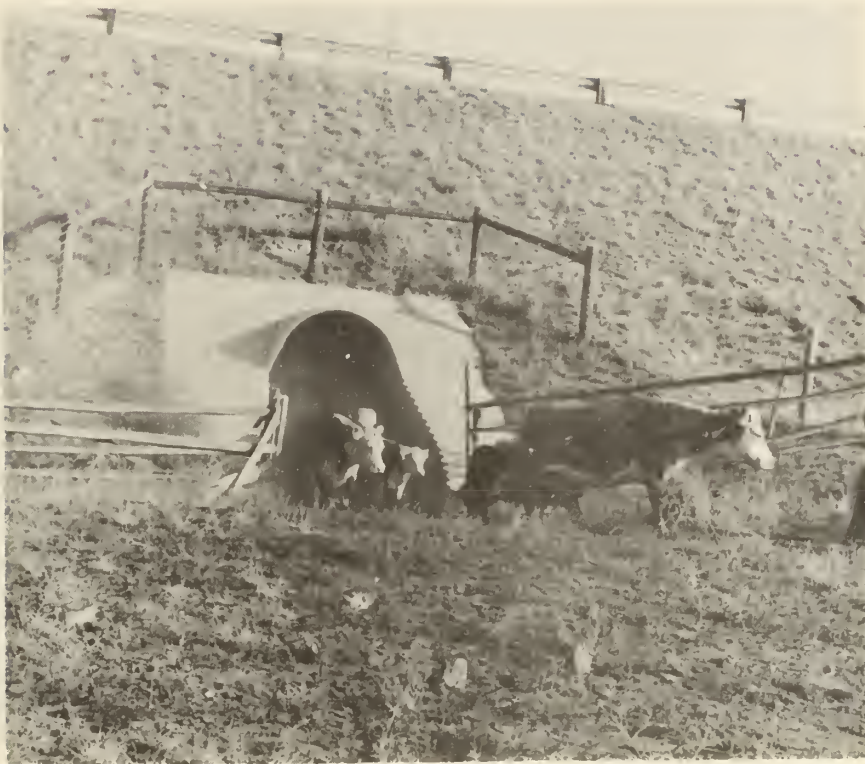
South Exit

6'11" x 8'6" x 262' long, Arch C.M.P., Design #99, old Std. Drgs. Herd of 200 head returning through pipe. This structure will handle three abreast. Notice there are no wires tied into structure. Cattle can climb up on wing wall, which can be injurious to cattle.

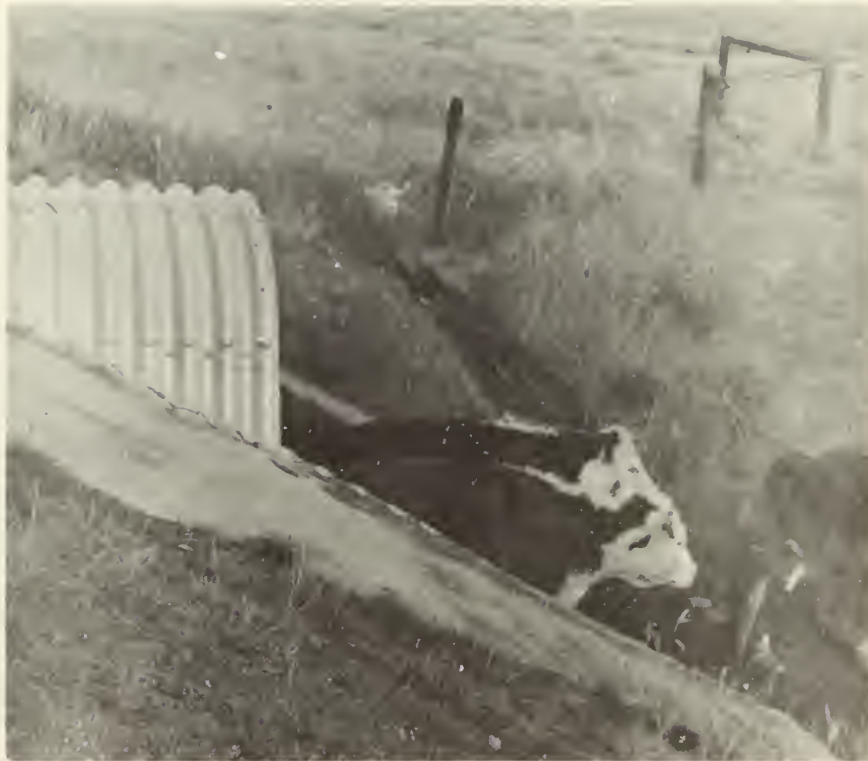
South Exit

6'11"s x 8'6"r x 262' long, Arch C.M.P., Design #99, old Std. Drgs. Continuing photos of 200 head herd movement north to south. Fencing should not be above stockpass, but tied into it. However, this underpass has high utility for stock movement.

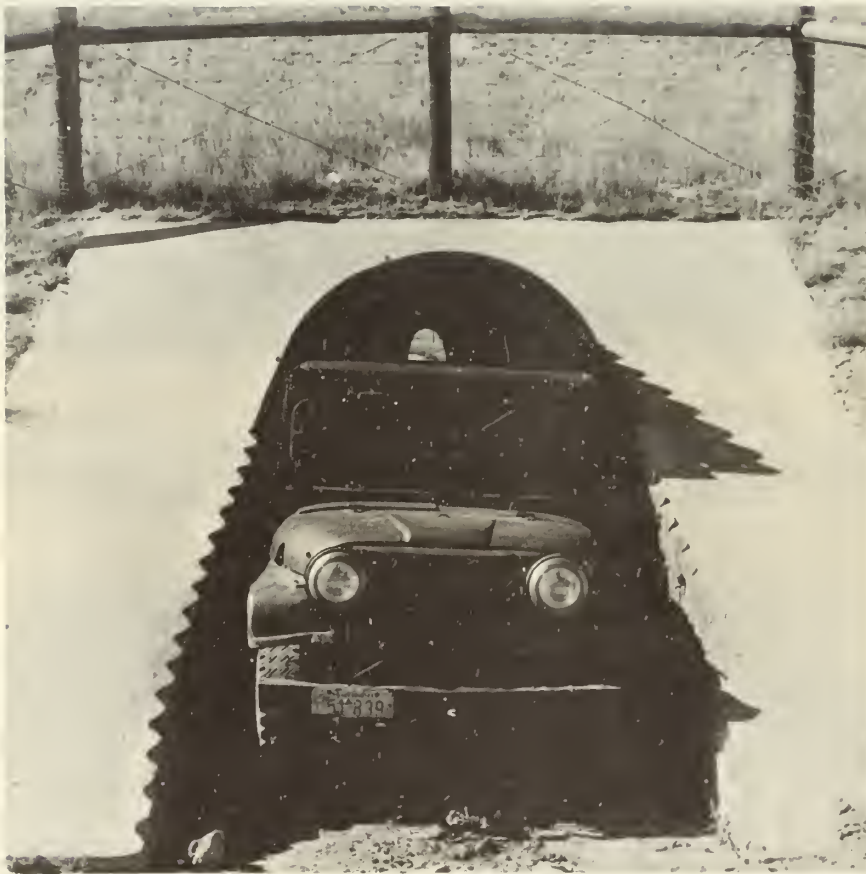
North End

6'11" x 8'6" x 262' long, Arch C.M.P., Design #99, old Std. Drgs. Landowner drives his jeep through underpass fairly often; rather close fit, however. Underpass will not accommodate a pickup.

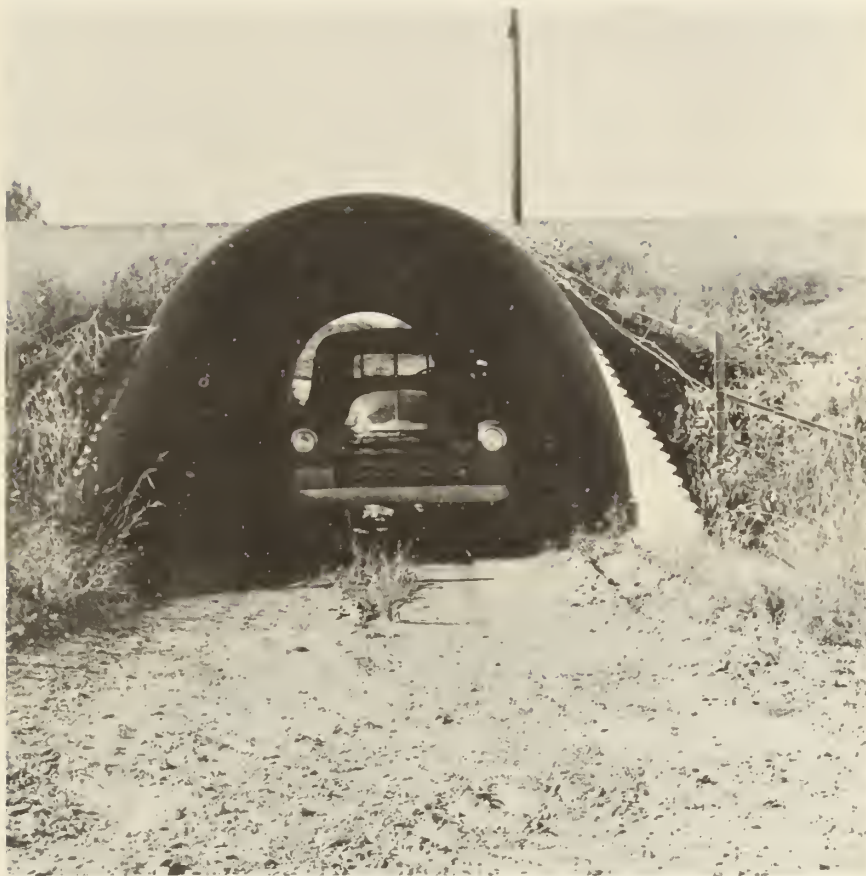
South End

10'10 $\frac{1}{2}$ "s x 9'11"r x 100' long, Arch C.M.P., #129, old Std. Drgs. Two-lane U.S. #10 near Big Horn Interchange, Treasure County. Underpass is heavily silted in from drainage. It will barely accommodate 1 $\frac{1}{2}$ -ton grain truck (8'x 8').

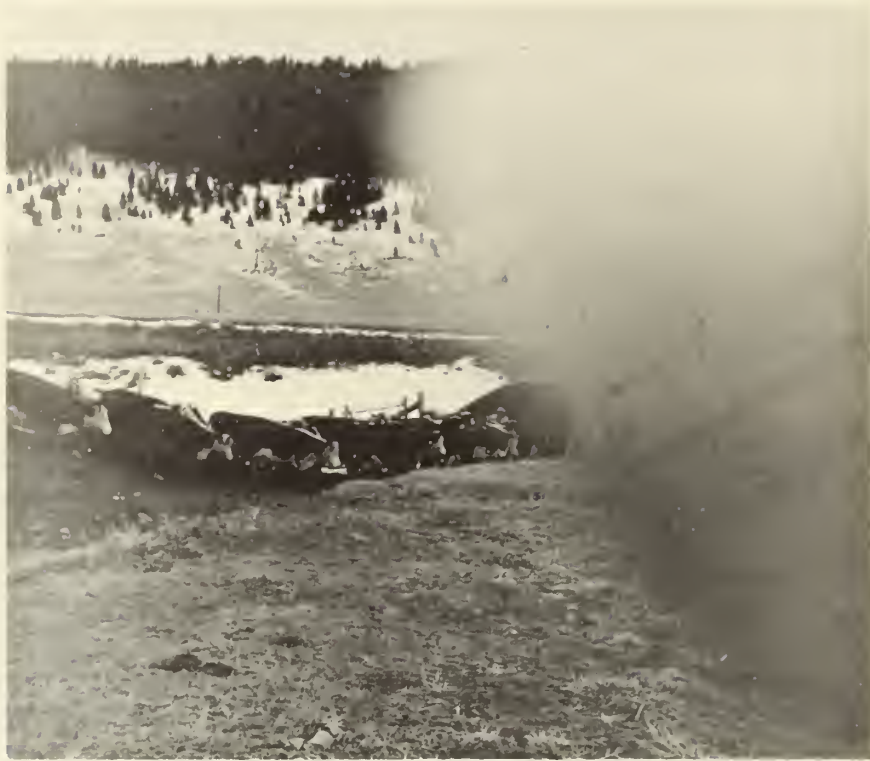
North Entrance

12'8''s x 8'7''r x 90' long, Squash C.M.P. Three miles north of Monida Pass under I-15 two-lane. Herd movement of 250 head 20 miles to winter pastures. Pipe is in low spot allowing spring runoff to silt it in. For this reason, there is only about 6 $\frac{1}{2}$ ' of clearance. High utility in fall, not so good in spring.

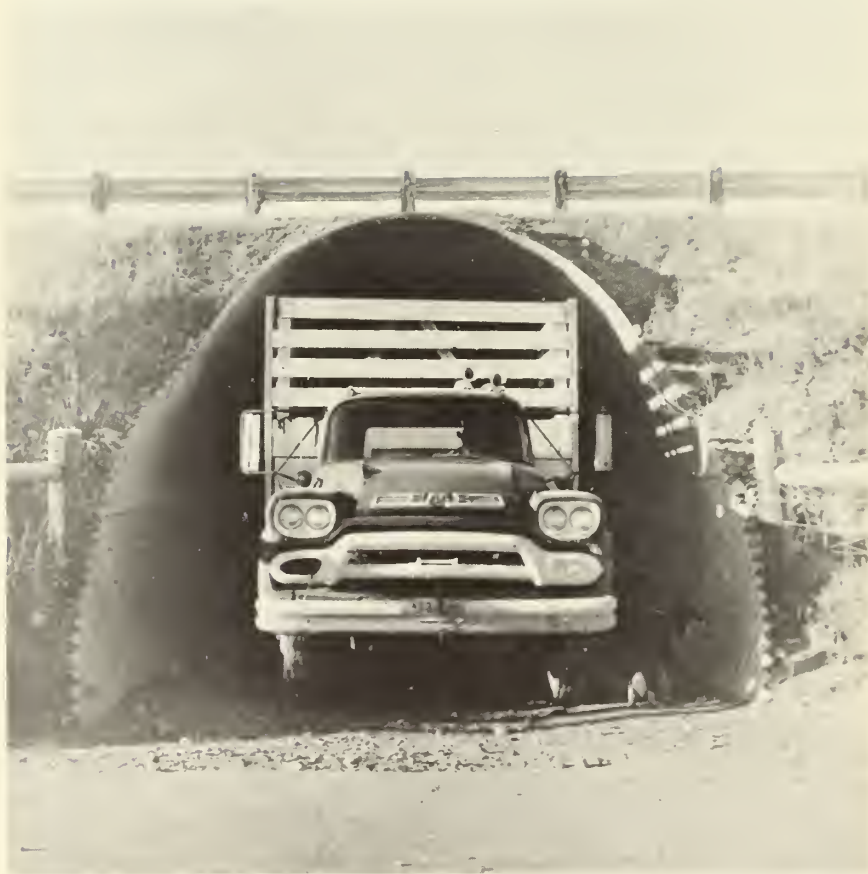
East Exit

180" diameter x 200' long, C.M.P., Std. Drg. 59-06. Three miles north of Lima under 4-lane I-15. Truck following end of 250 head herd movement; 8' wide x 10' high 2-ton stock truck. There is about 14' of roadway, leaving this underpass a little too full for optional machinery usage.

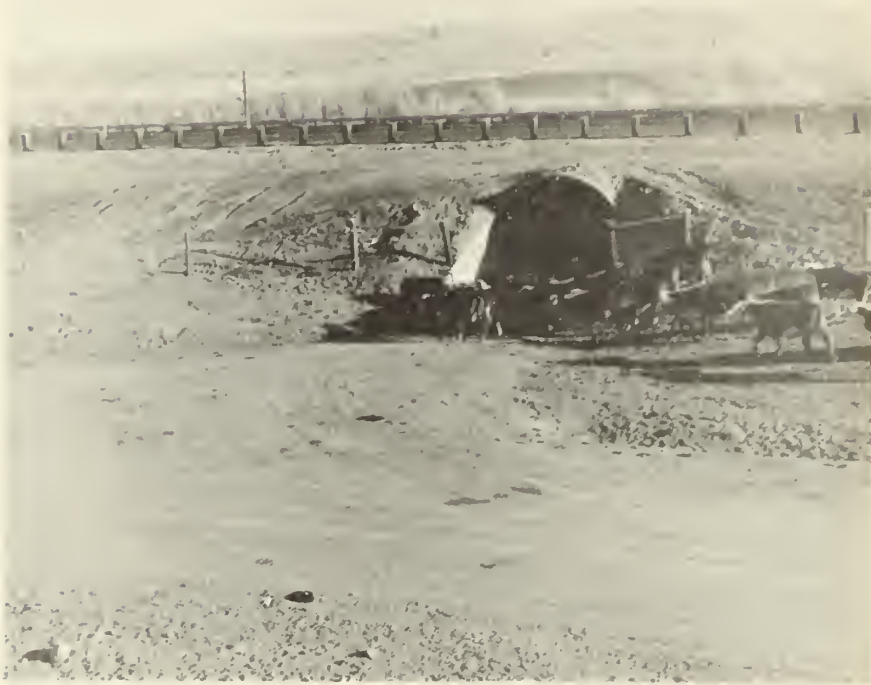
West Entrance From Frontage Road

180' diameter x 200' long, C.M.P., Std. Drg. 59-06. Three miles north of Lima under I-15, 4-lane. Herd movement of 400 head west to east, summer to winter pastures. Rather improper fencing due to frontage road. Cattle did not hesitate at going through structure and they had been through here only once. This was the first season in use.
